City of Redmond

Facility Condition Assessment

Summary Report

Prepared by MENG Analysis - August 23, 2024

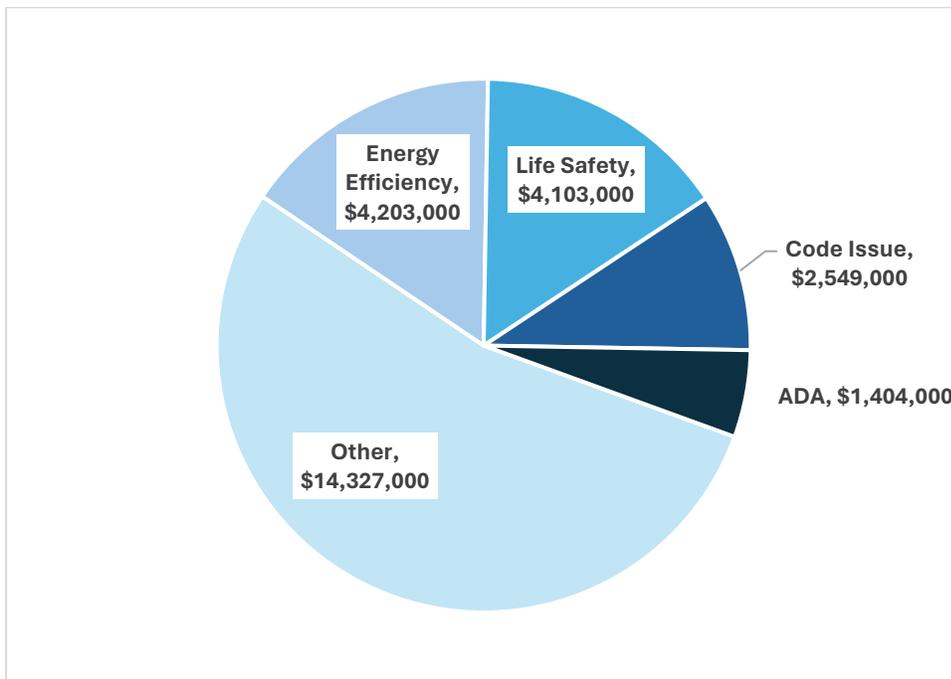
Figure 1. Deficiencies by Action Type

As seen in Figure 1, the majority of the facilities' deficiencies fall under the “Other” category. This is the broadest category type and captures many aesthetic and general building issues, such as worn or stained carpet, stained or damaged ceiling tiles, worn or scratched doors and walls, aged roofing and plumbing, and many other others. The largest deficiency in this category is related to the siding at Fire Station 17. The City is aware of this issue and has a team under contract to correct it over the spring-summer of 2024.

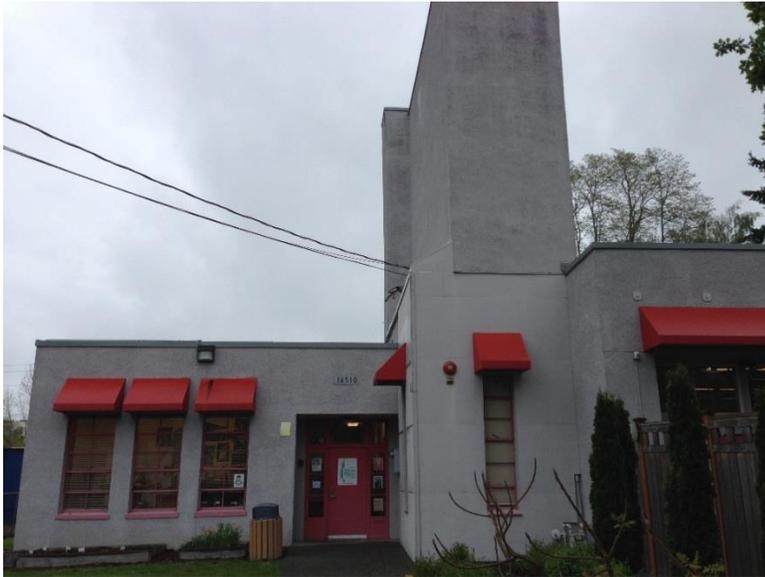
OLD FIRE STATION / TEEN CENTER

- **Summary of Asbestos-Containing Materials**

Homogeneous Area	Description	Quantity	Cat. / Type	Percent Asbestos
Exterior metal framed windows	Window Glazing (white, brittle)	2,000 LF	Misc. / NF	2% Chrysotile
Floor in southwest office, north storage, south office	Trace black flooring mastic	800 SF	Misc. / NF	5% Chrysotile
Walls and ceilings	White skim coating on plaster and CMU walls	T / O Walls and Ceilings	Surf. / F	4% Chrysotile
Game Room	Diner-style seating base (red, cementitious)	70 SF	Misc. / NF	4% Chrysotile
Basement	Hard mudded piping manifold insulation (white, hard)	10 LF	TSI / F	20% Chrysotile 15% Amosite
Basement / piping tunnels, in walls and ceilings	Hard mudded water piping fittings, elbows	350 Each	TSI / F	25% Chrysotile 21% Amosite
Basement / piping tunnels, in walls and ceilings	Aircell piping insulation (fabric lagging on cardboard layers)	2,500 LF	TSI / F	50% Chrysotile
Basement boiler	PACM Boiler breach gasket	2 Each	Misc. / F	Presumed Asbestos-Containing Material

Basement boiler	PACM Boiler breach insulation	10 SF	TSI / F	Presumed Asbestos-Containing Material

Basement boiler	AACM Boiler refractory brick	50 SF	Misc. / F	Assumed Asbestos- Containing Material
-----------------	---------------------------------	-------	-----------	--

Location	Component	Substrate	Color	Lead Concentration (mg/cm ²)
Old Fire Station	Door Casing	Wood	Blue	2.00
Old Fire Station	Door	Wood	Red	2.30
Old Fire Station	Window Panel	Other	Black	3.00

Sample Number	Location	Description	Results (mg/kg)
RED-OFC-AS-01	Old Fire Station – media lab wall	CMU	<18.0
RED-OFC-AS-02	Old Fire Station – media lab wall	Grey CMU mortar	<19.0

Location	PCB Light Ballasts	Fluorescent Lamps	High Intensity Discharge Lamps (HID)
Old Fire Station / Teen Center	135	250	10
